Re: Destruction of Fish Habitat in and around Strawberry Island

RE: Strawberry Island Habitat Assessment

Summary

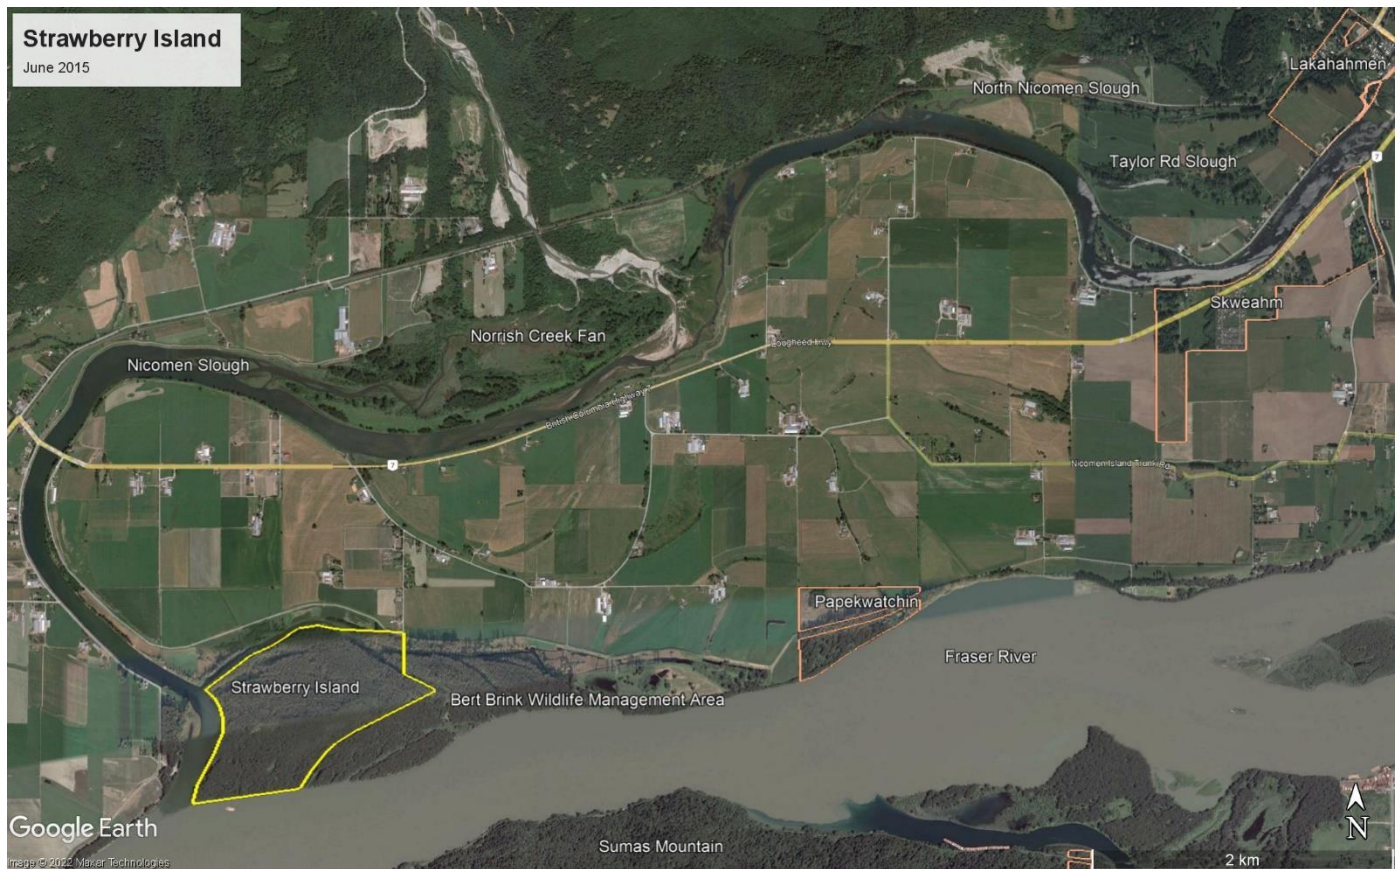
Figure 1: Lower Nicomen Slough in June 2015 showing Strawberry Island, prior to clearing. The subject property is outlined in yellow.

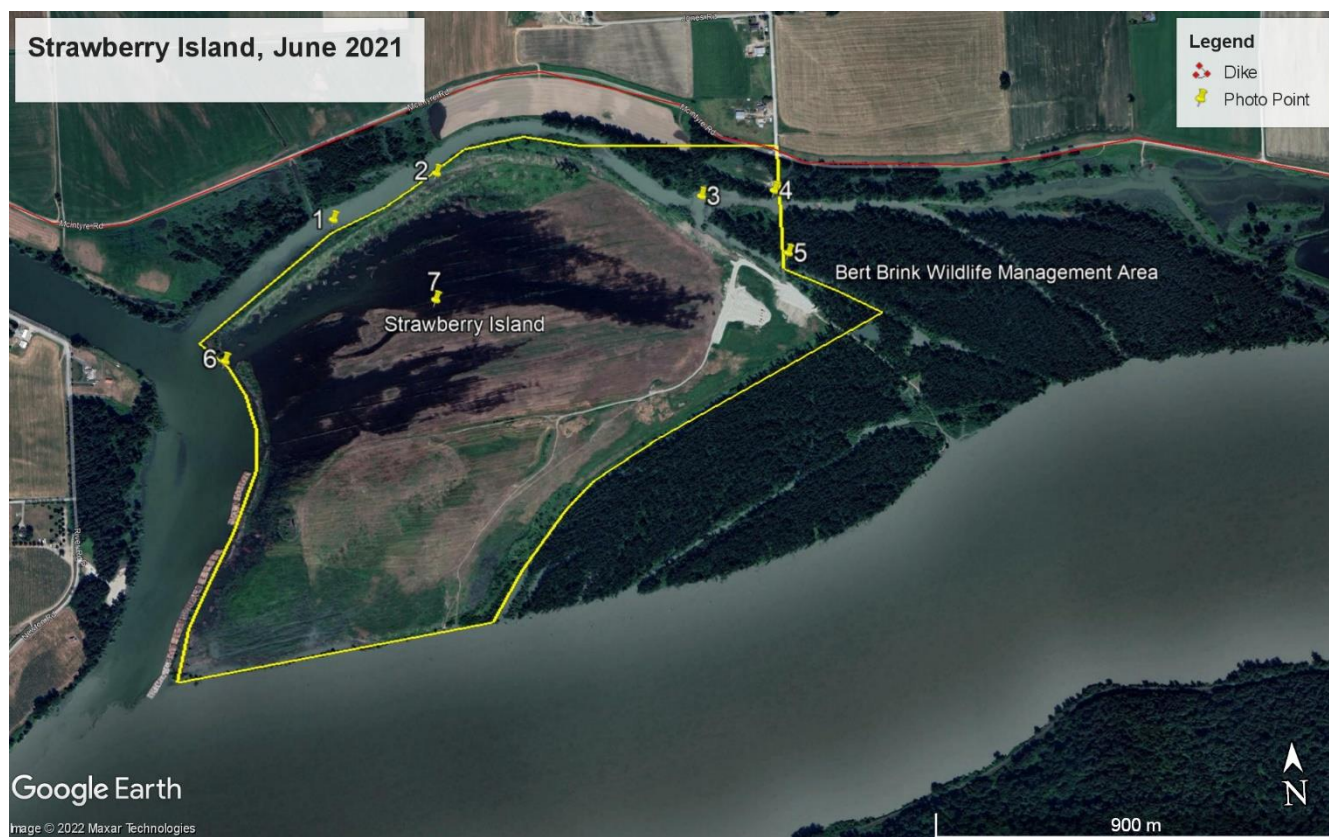
Figure 2: Strawberry Island in June 2021, at moderate freshet level. The Island was clearcut to the border of the Bert Brink WMA in 2015-2016. Numbered points correspond to site photos and descriptions below.

The recent and ongoing issues observed on June 10 are summarized in the following sections. Location numbers refer to sites shown on Figure 2. Unless noted otherwise all photos were taken on June 10, 2022.

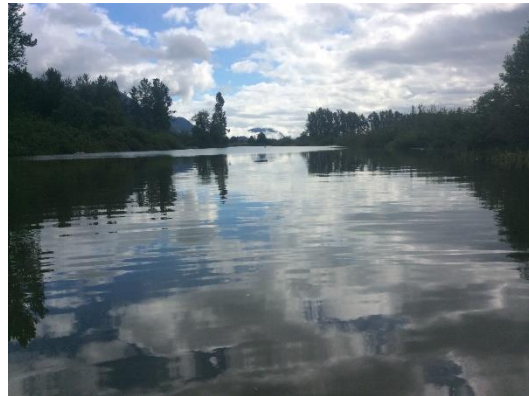
Site 1: Strawberry Slough

The north-west edge of Strawberry Island (right side of photo) retains a narrow band of intact riparian area. The slough is 50 m wide when full, but dries upstream of this point in late summer.

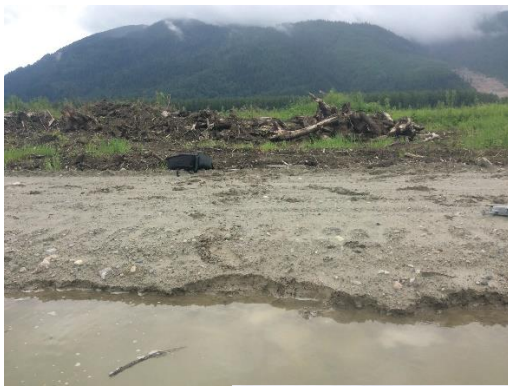
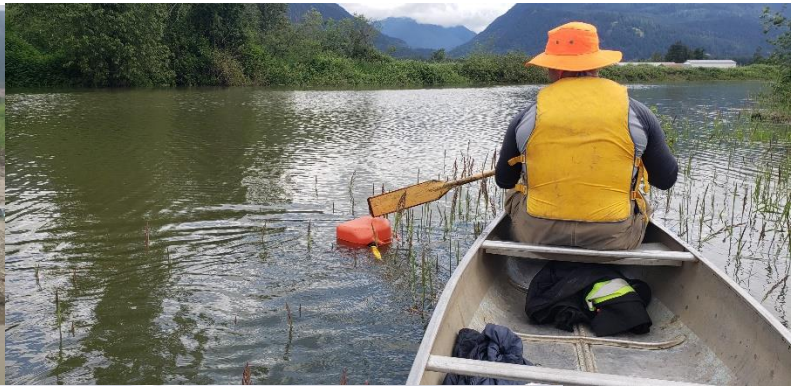
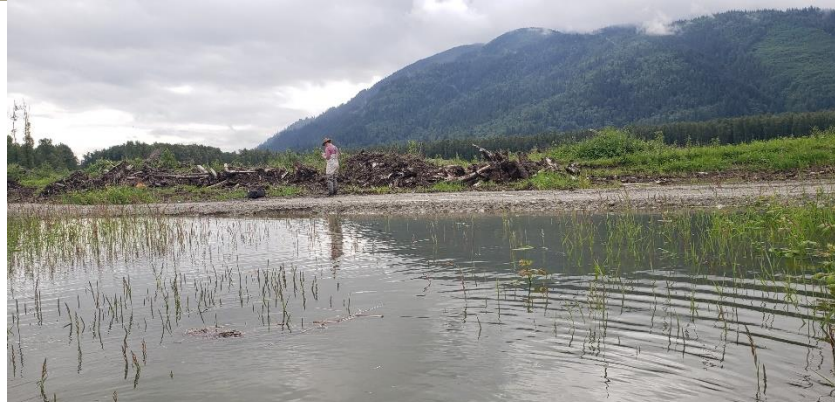
Site 2:

A recently-constructed access road is blocking a seasonal side channel. The Fill material is fully saturated (like quicksand), actively eroding and will be overtopped within a day or two. An open jerry can was found floating at the site.

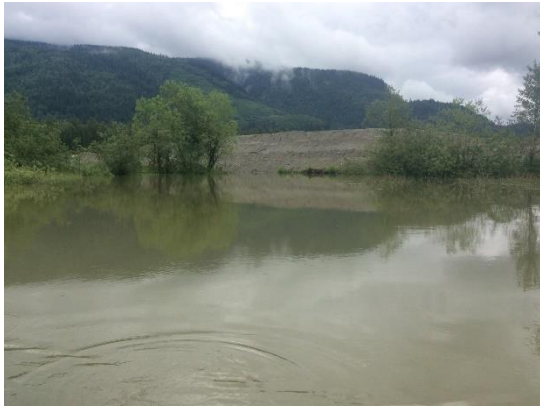
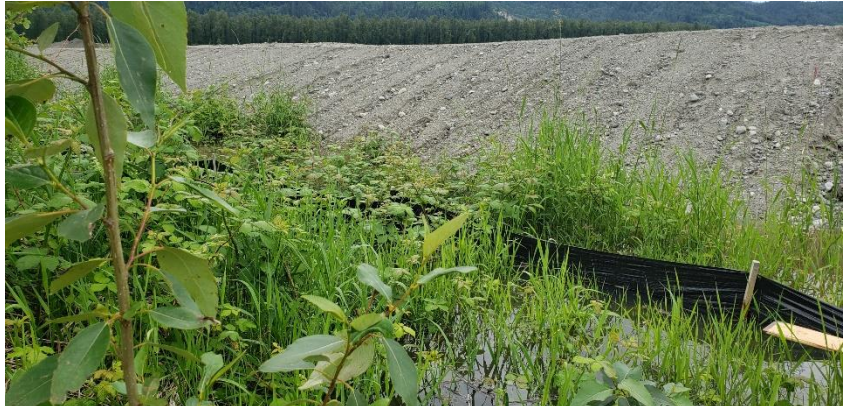
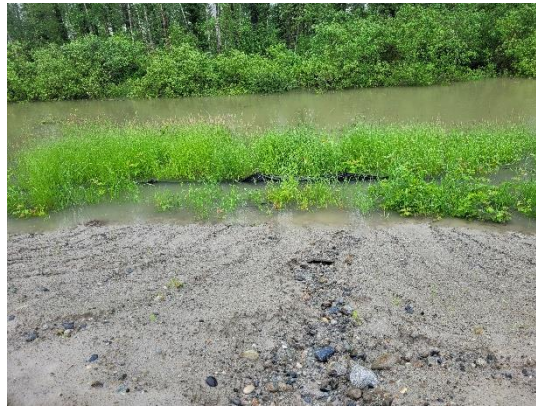
Site 3. Confluence of side channels

Under current freshet conditions water extends past silt fencing to toe of the dike. Silt fencing is overtopped in places and does not extend the full length of the dike that is exposed to water. Rill erosion on the dike slope is evident along its entire length.

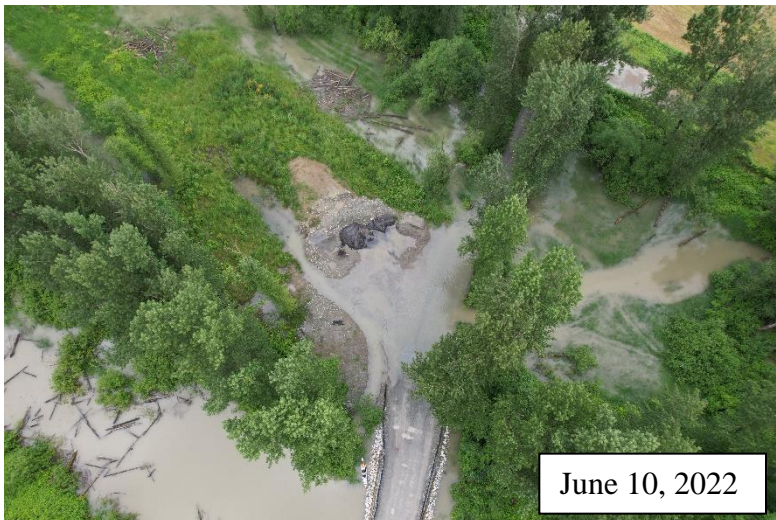
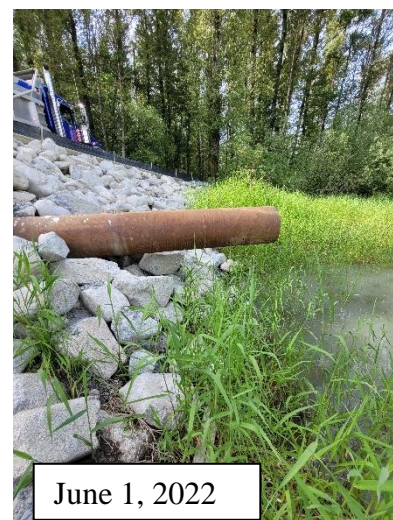
Site 4: North causeway crossing

The access road causeways completely block the slough. The culvert in the causeway is grossly undersized and perched, blocking fish access at all but the highest water levels. The access road is currently completely submerged with flowing water eroding stockpiled gravel and ground asphalt (black piles near centre of drone photo).

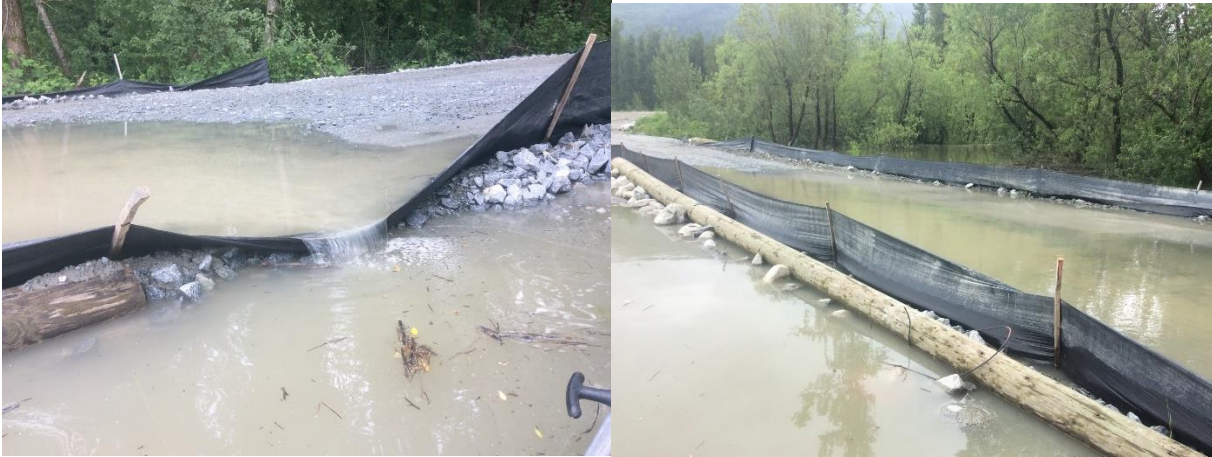
Site 5: South Causeway crossing

The causeway is completely submerged and eroding. The silt fencing is overtopped and unsecured pressure-treated poles about to float away.

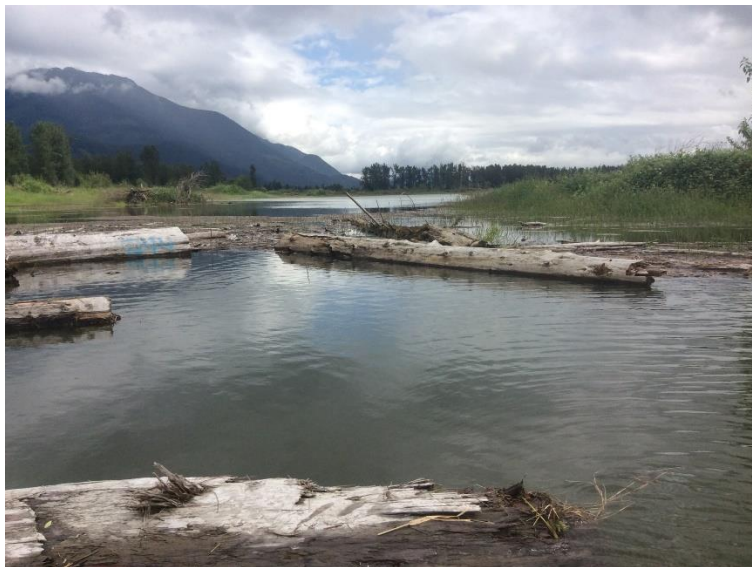
Site 6: Strawberry Island Wetland connection to Nicomen Slough

Water was over 2 m deep at the connection between the wetland and Nicomen Slough channel on June 10.

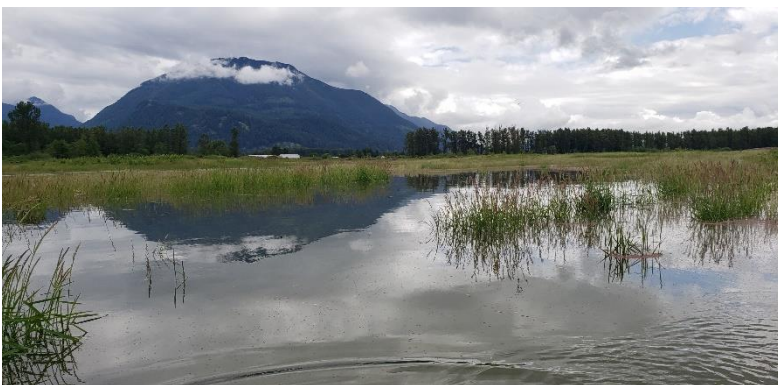
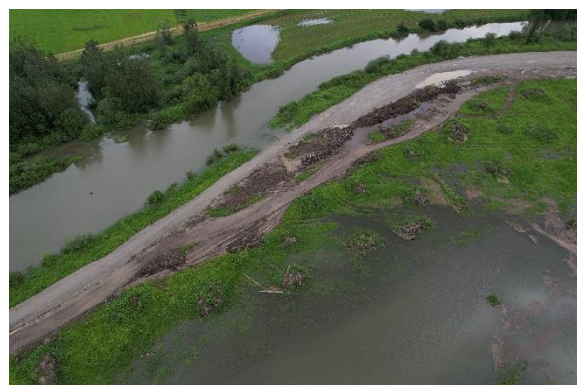
Site 7: Strawberry Island Wetland

Approximately 85 acres are currently underwater and accessible to fish, as they are virtually every year during freshet. It appears that the landowner intends to dike off the entire area.

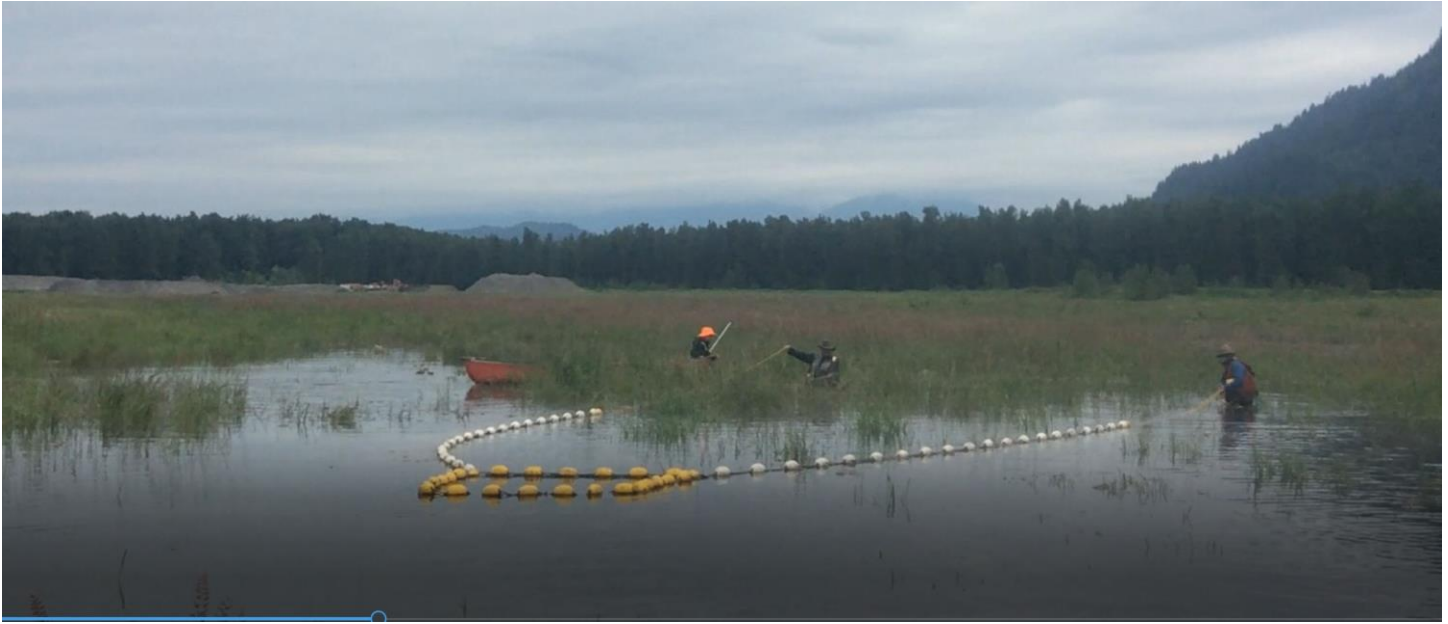
On June 14, two hauls of a 20 m bag seine covering approximately 650 m² habitat 7 indigenous species of fish including 52 juvenile salmonids (Figure 8, Table 2). Given that approximately 375, 000 m² of the island was flooded at the time, and catch efficiency is always less than 100 percent, an minimum of 30,000 juvenile salmonids are estimated to have been present were present on the flooded portion of Strawberry Island at the time.

Figure 1: Seine haul on Strawberry Island, June 14, 2022.

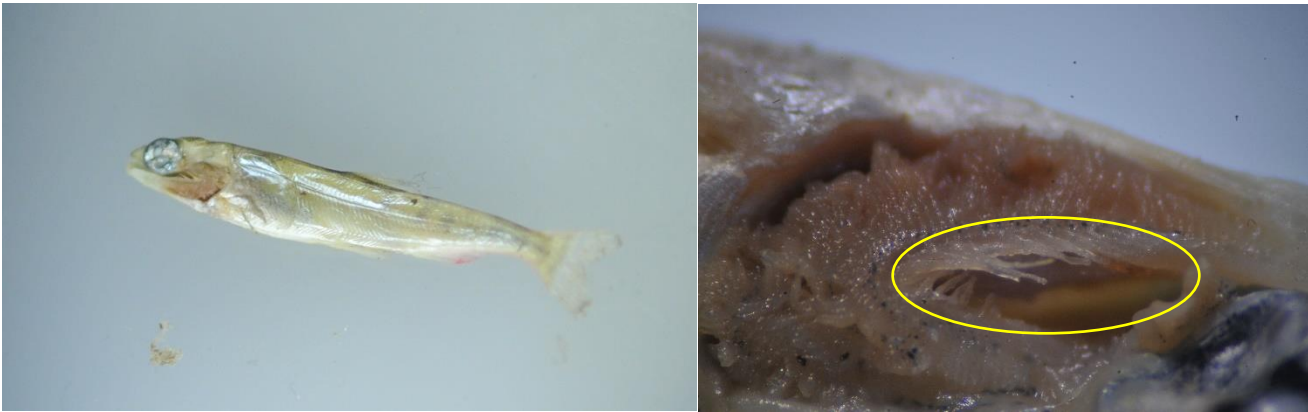
The majority of salmonids caught (41) were river-rearing sockeye fry, presumably of Harrison River origin. Identification was confirmed by the number and morphology of gill rakers on two individuals (Figure 9). Fin clips from all Chinook and 10 Sockeye were collected and will be included with samples from sites across the lower Fraser collected by Resilient Waters to be submitted to the DFO conservation genetics laboratory at the end of the field season (late fall) to confirm stock identification.

Figure 9: Sockeye salmon fry (39 mm) showing over 20 long slender gill rakers (right). Chum Salmon would have short, stubby gill rakers fewer in number (McPhail 2007)

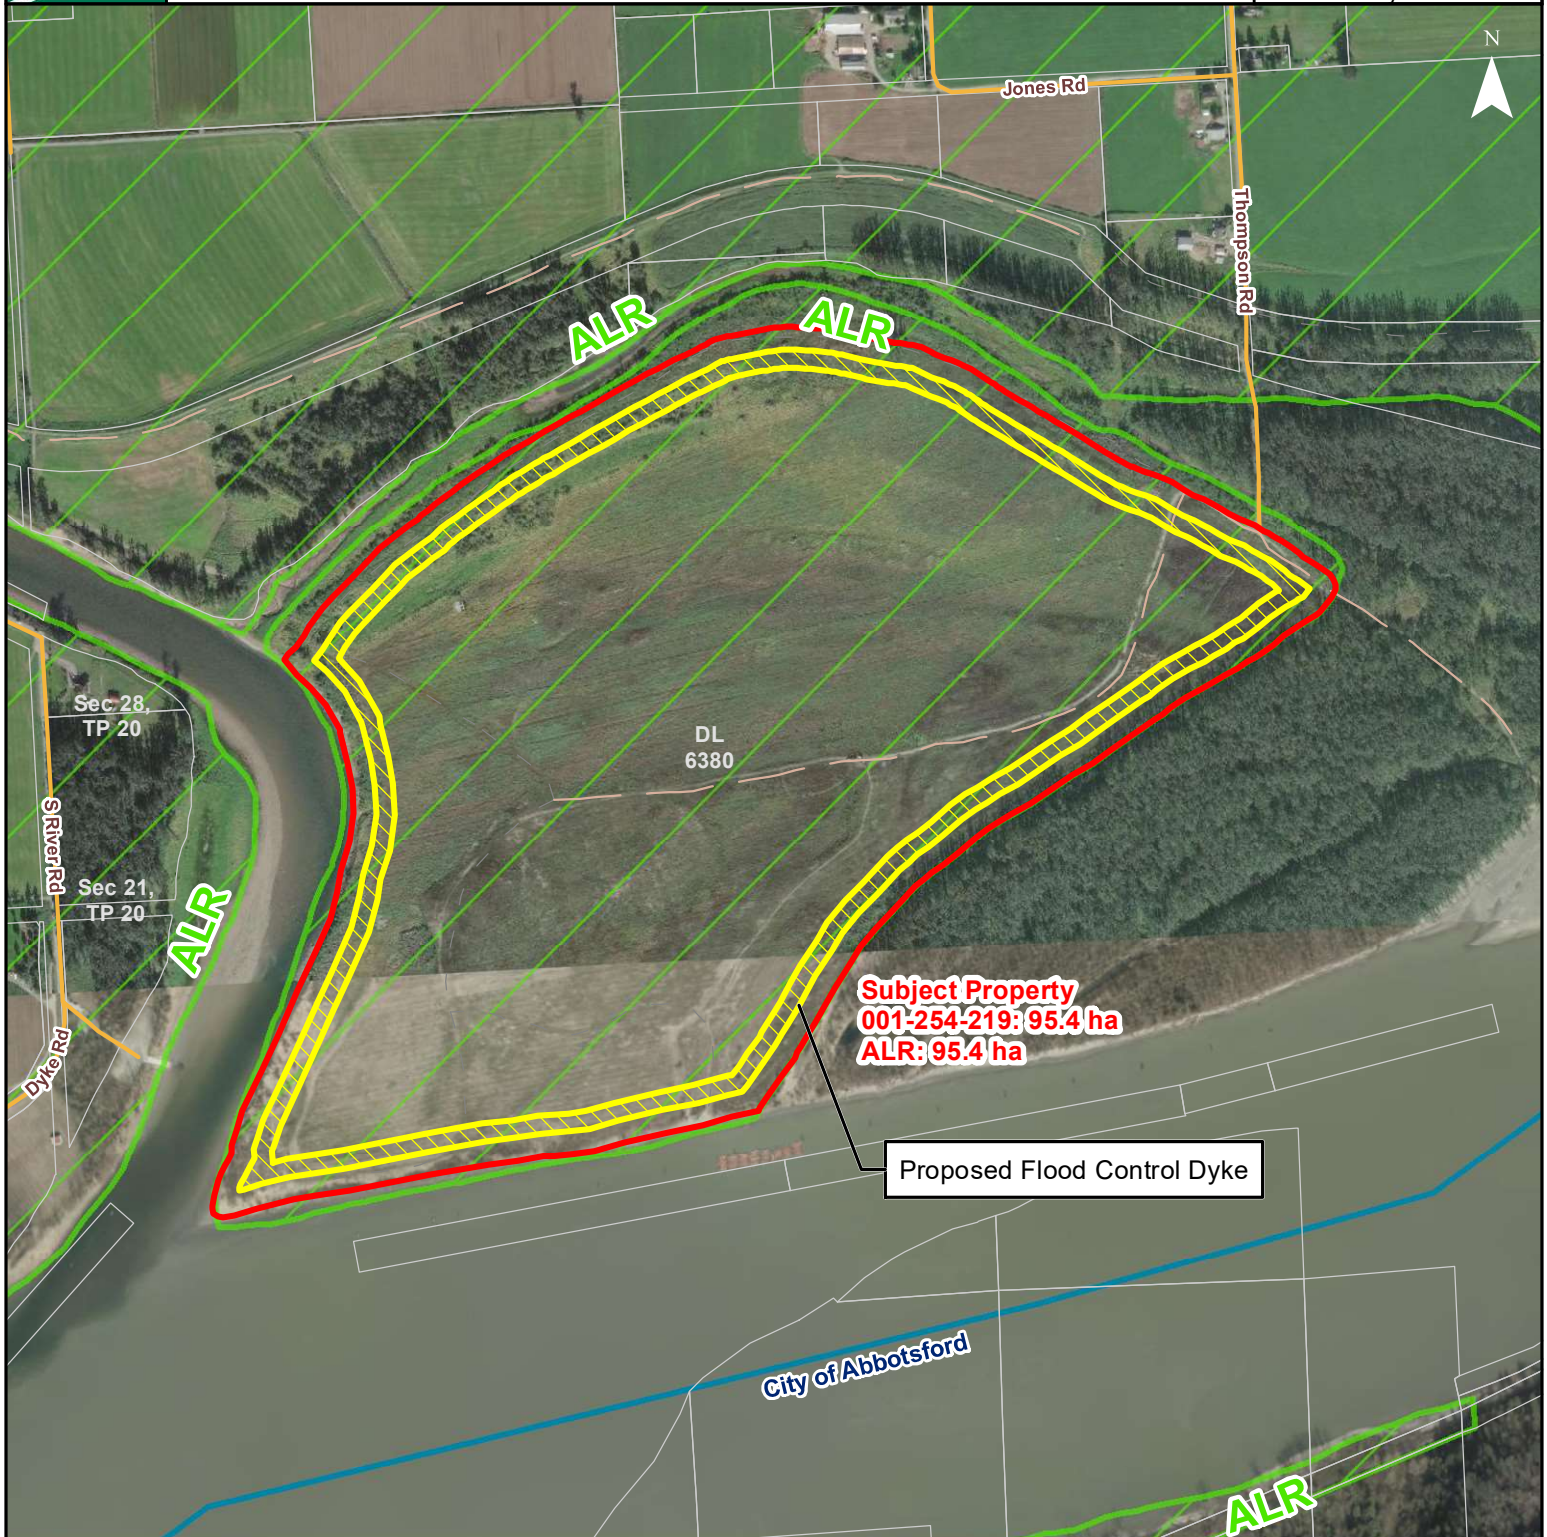
Proposed Flood Control Dyke

- Subject Property (District Lot 6380, Group 1, New Westminster District, BC)
- Approved Fill Placement Area (~10.0 ha)
- Agricultural Land Reserve
- PMBC Parcel Cadastre

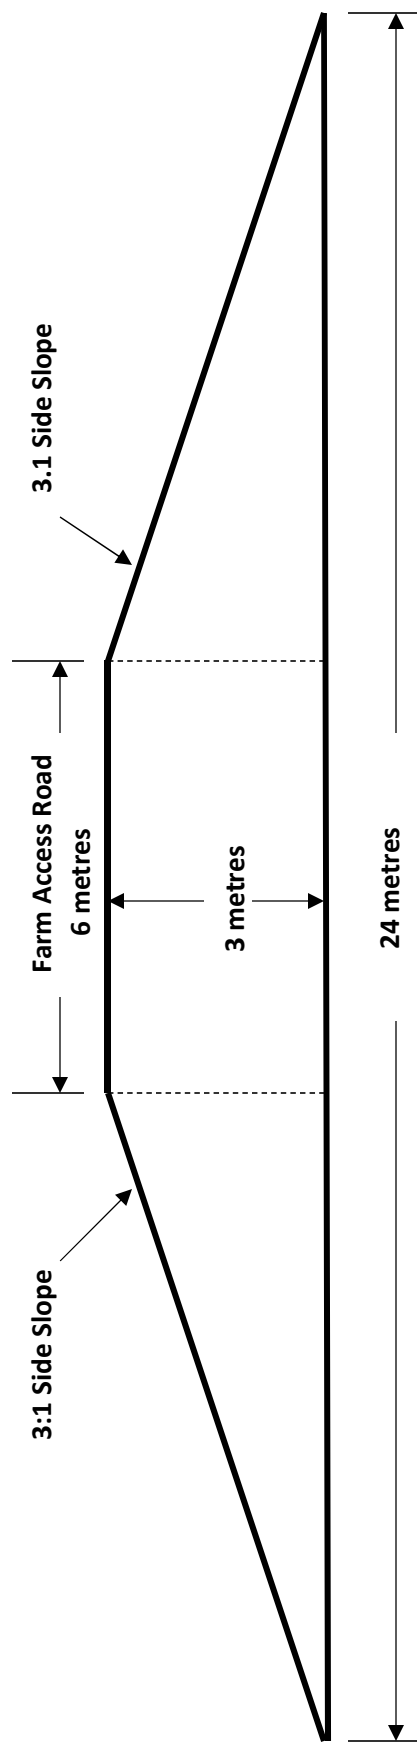
Dike Cross – Section

Area of cross-section = 45 m²
Approximate length of perimeter diking = 4,200 m
Estimated volume of fill required = 189,000 m³
